# Dayton Boulevard at Morrison Springs Road Safety Analysis Memo

From: Geneva Dowdy, PE CC: Gregory Tate

Project: Dayton Boulevard at Morrison Springs Road

Subject: Intersection Spot Safety Improvements

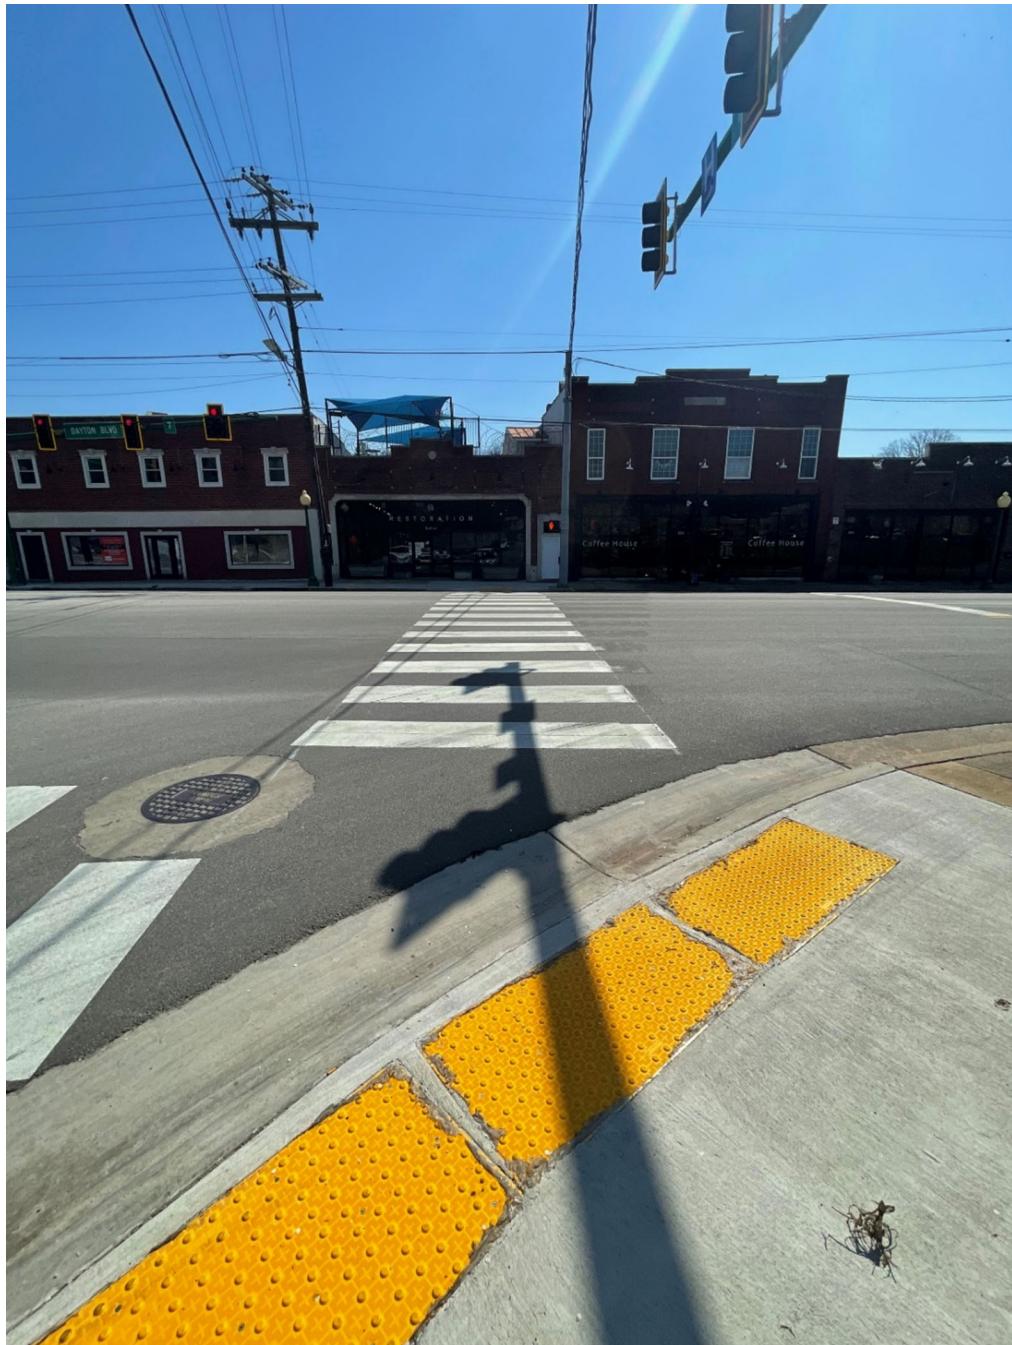
Figure 1 – Looking eastbound across Dayton Boulevard (Southwest corner)

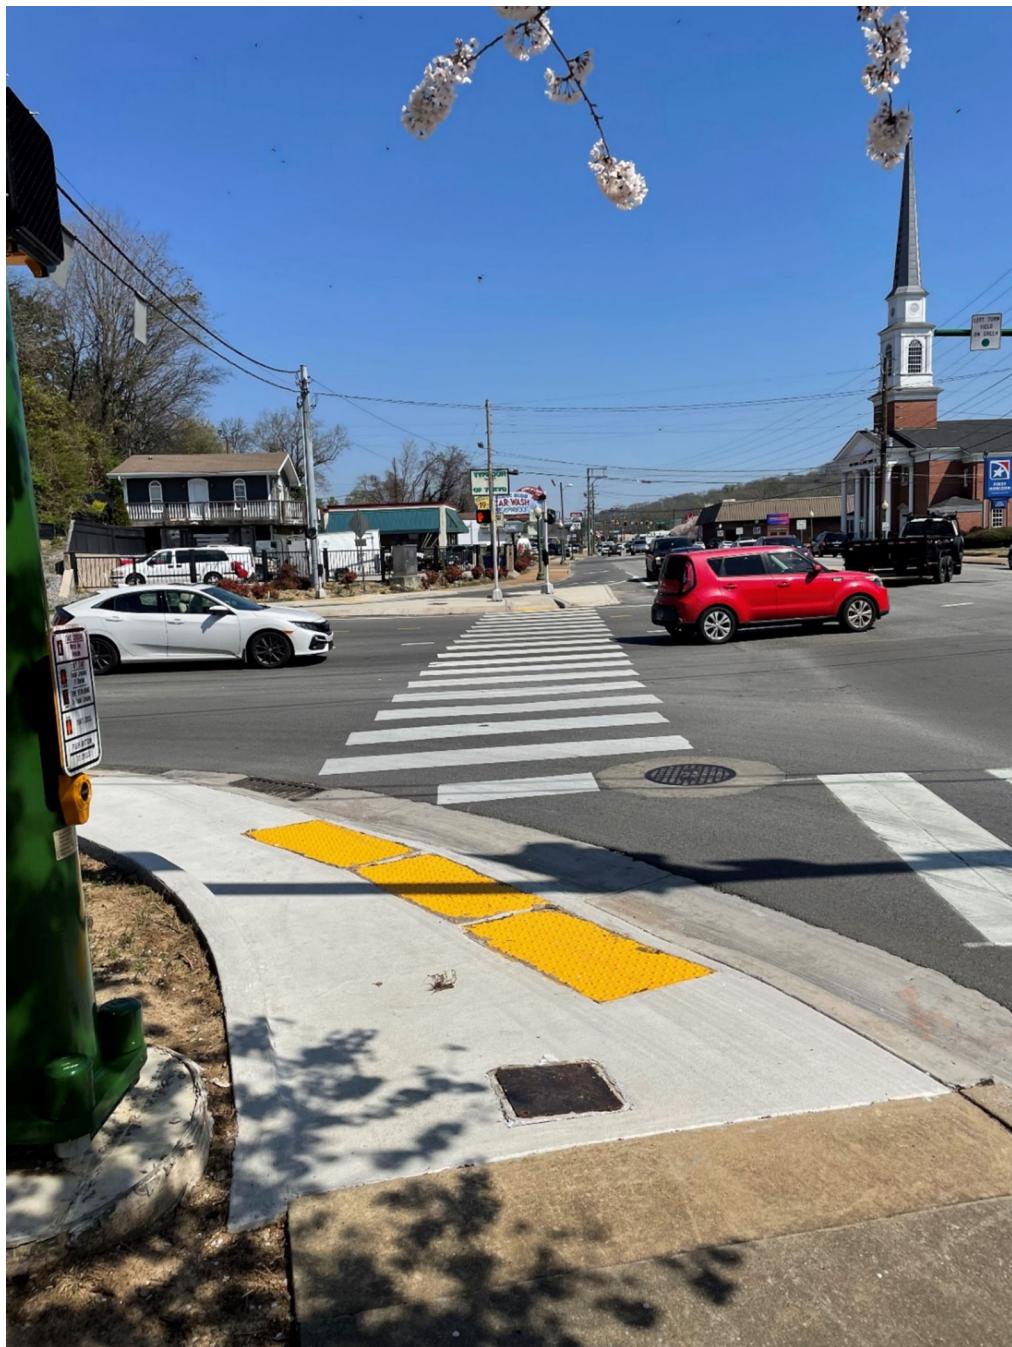
Figure 2 – Looking northbound across Morrison Springs Road (Southwest corner)

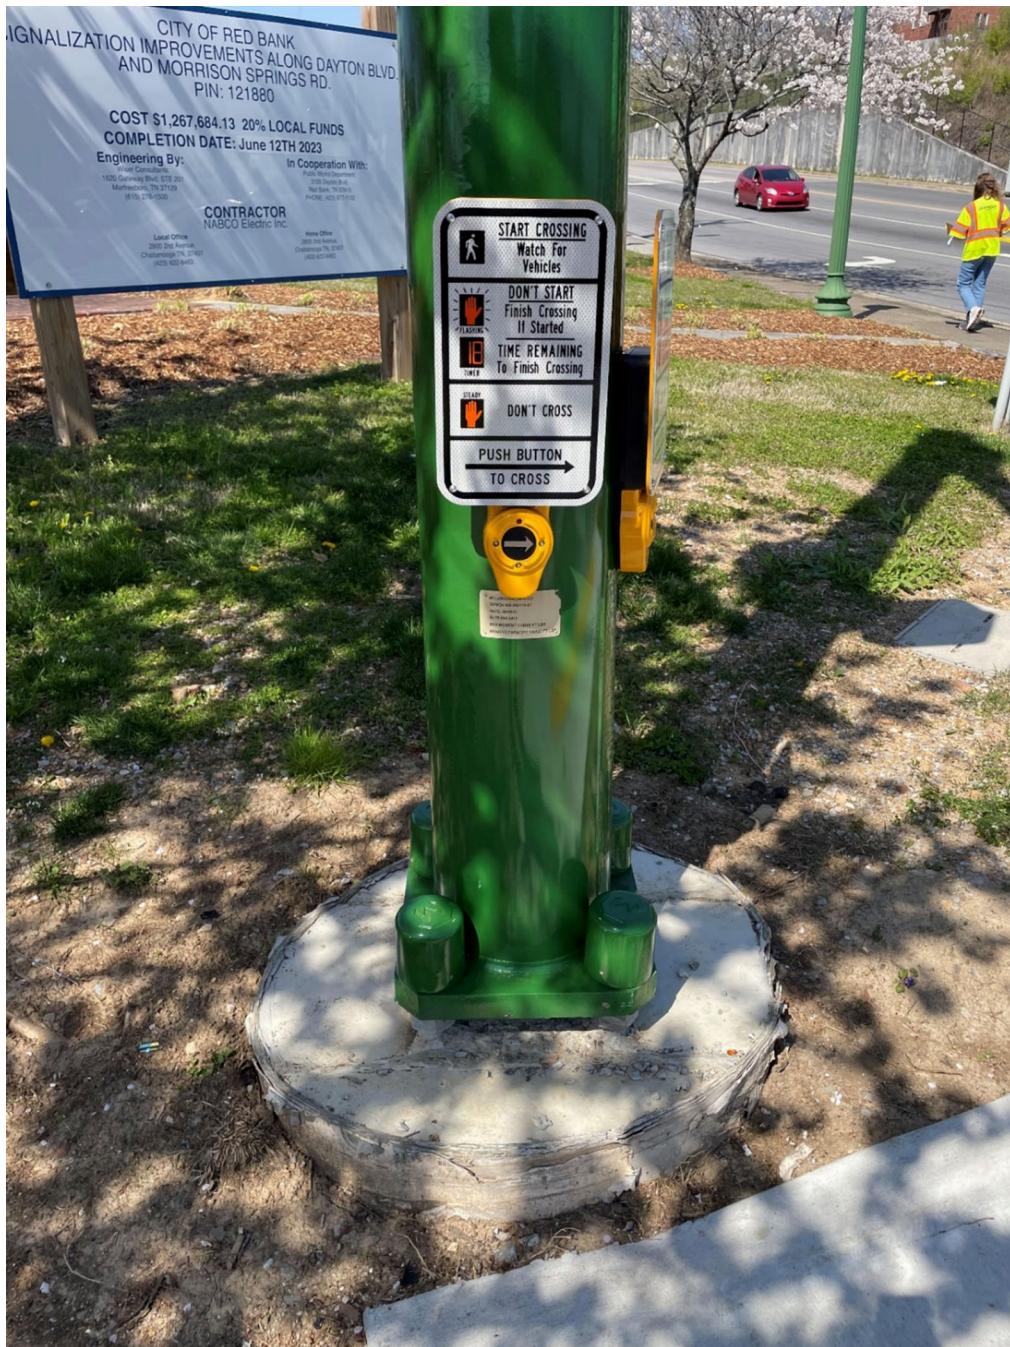
Figure 3 – Southwest Corner Pushbutton for crossing Morrison Springs Road

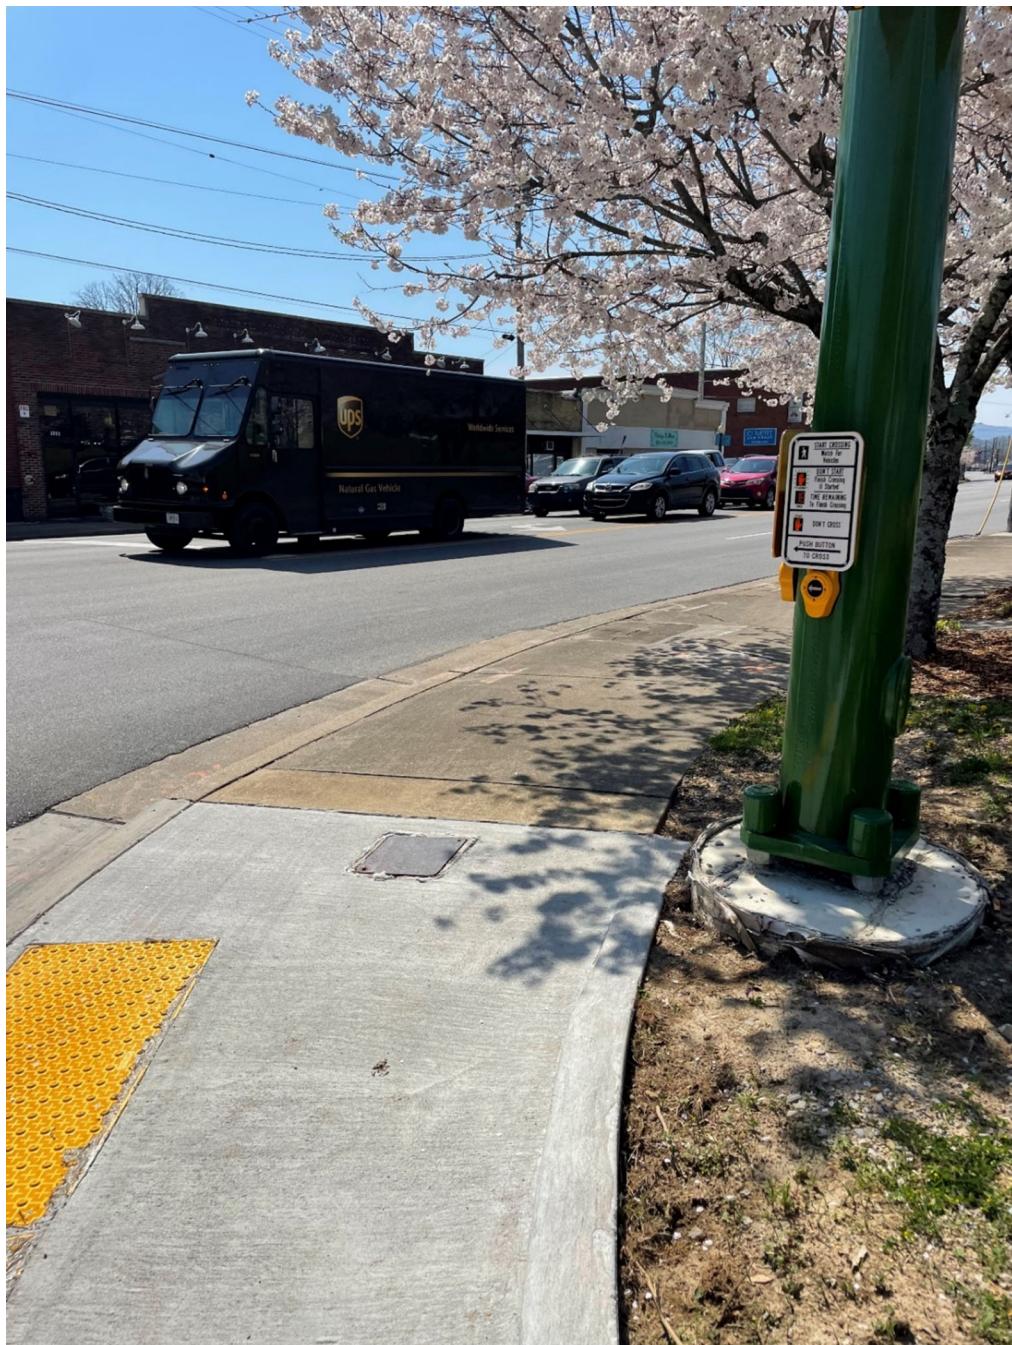
Figure 4 – Southwest Corner Pushbutton for crossing Dayton Boulevard

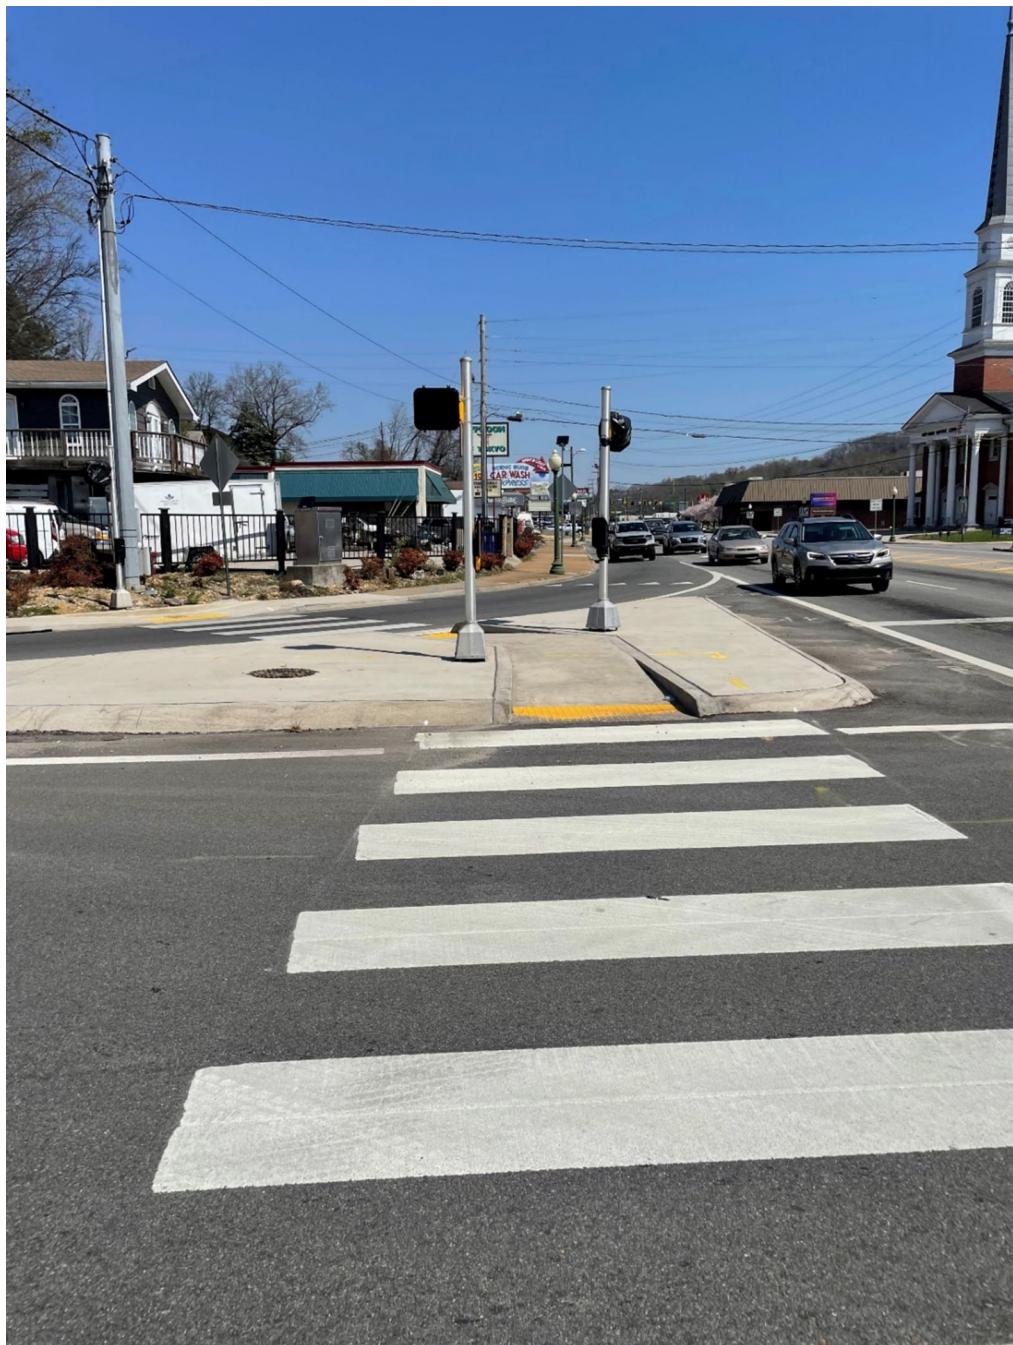
Figure 5 – Looking northbound across Dayton Boulevard at channelized island

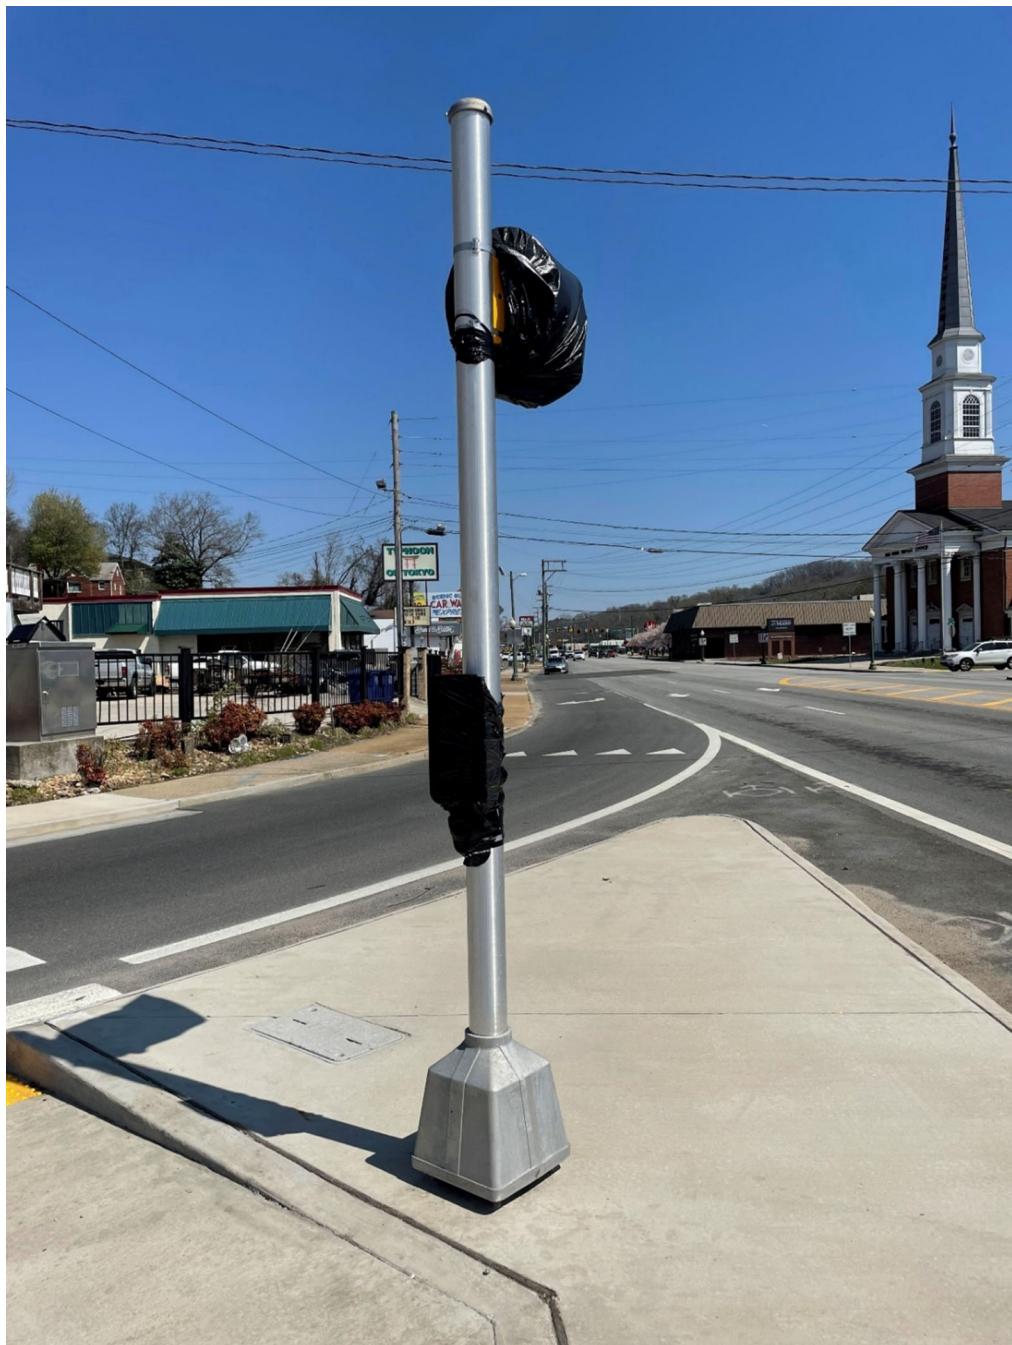
Figure 6 – Northwest Corner New Pedestrian Signal Head with Pushbutton on Channelization Island

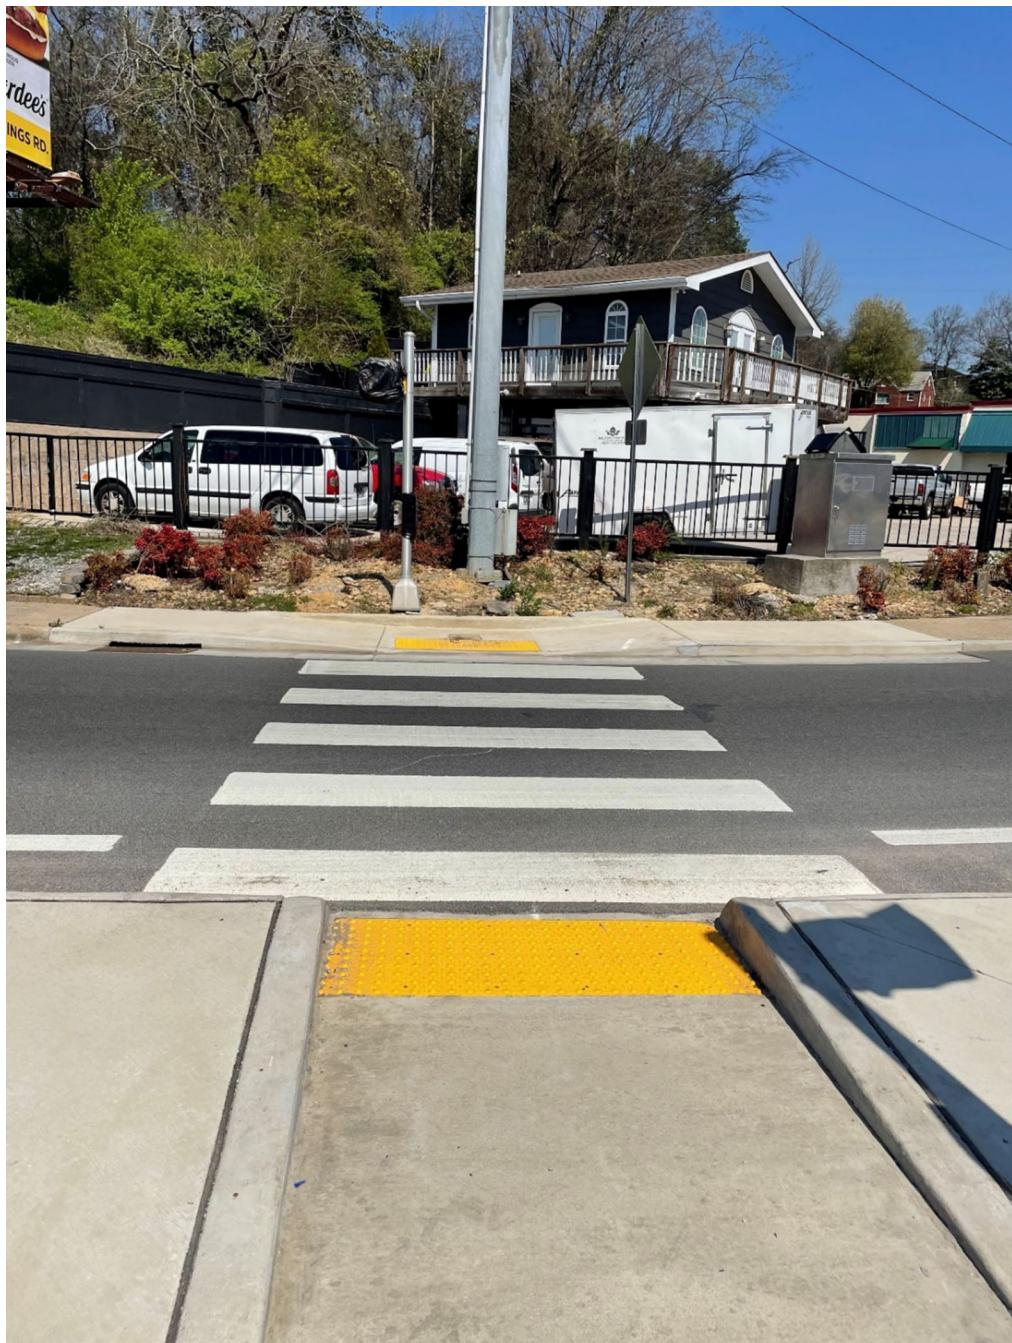
Figure 7 – Northbound Channelization Crosswalk across Dayton Boulevard

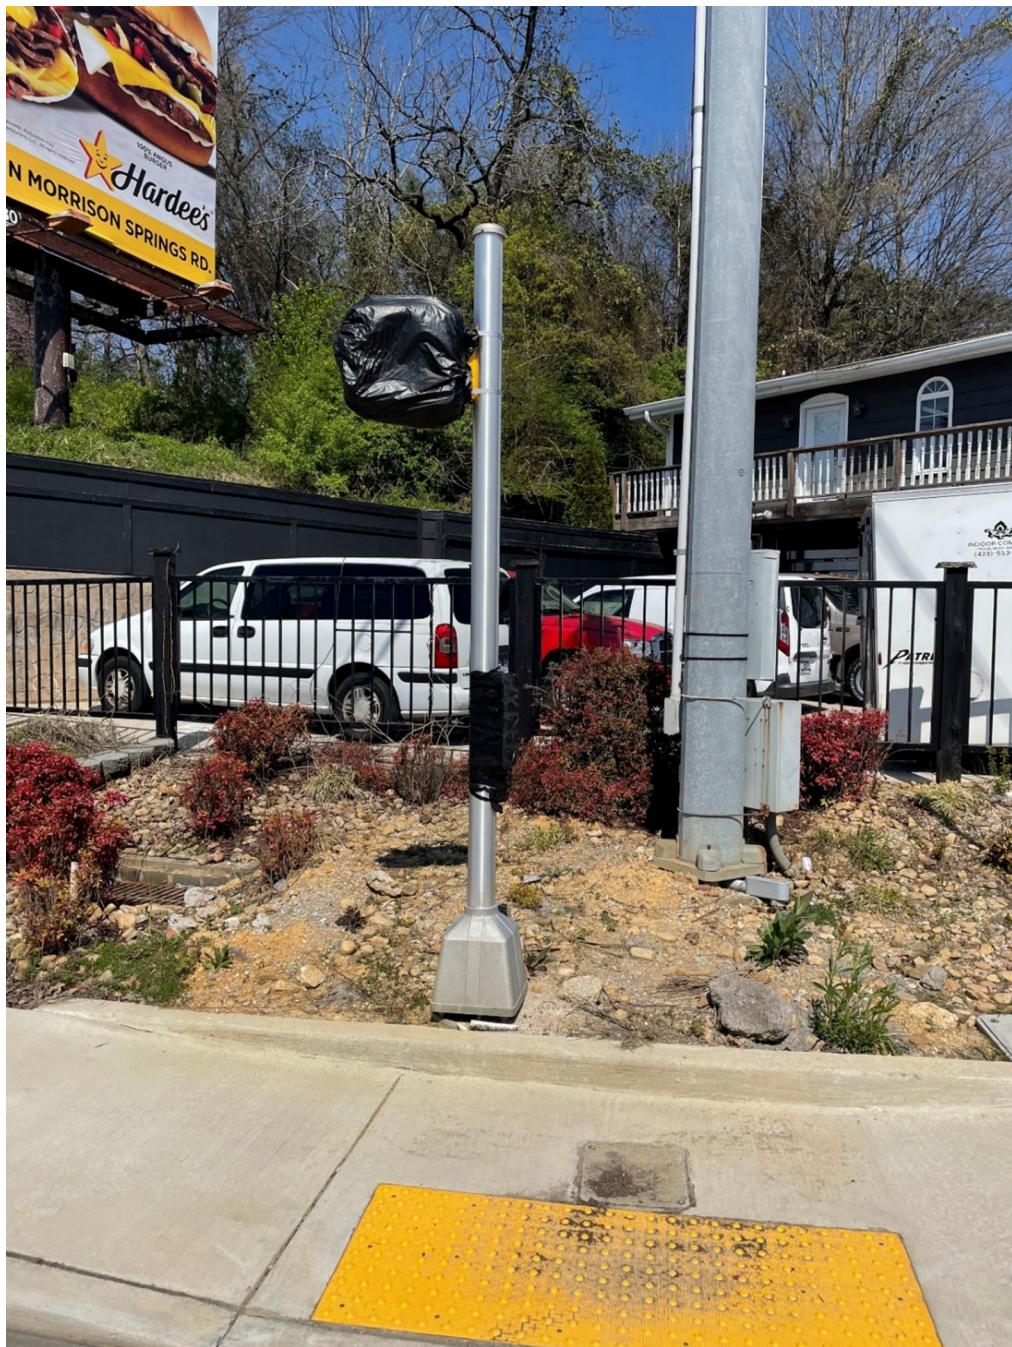
Figure 8 - Northwest Corner New Pedestrian Signal Head with Pushbutton at channelized crossing

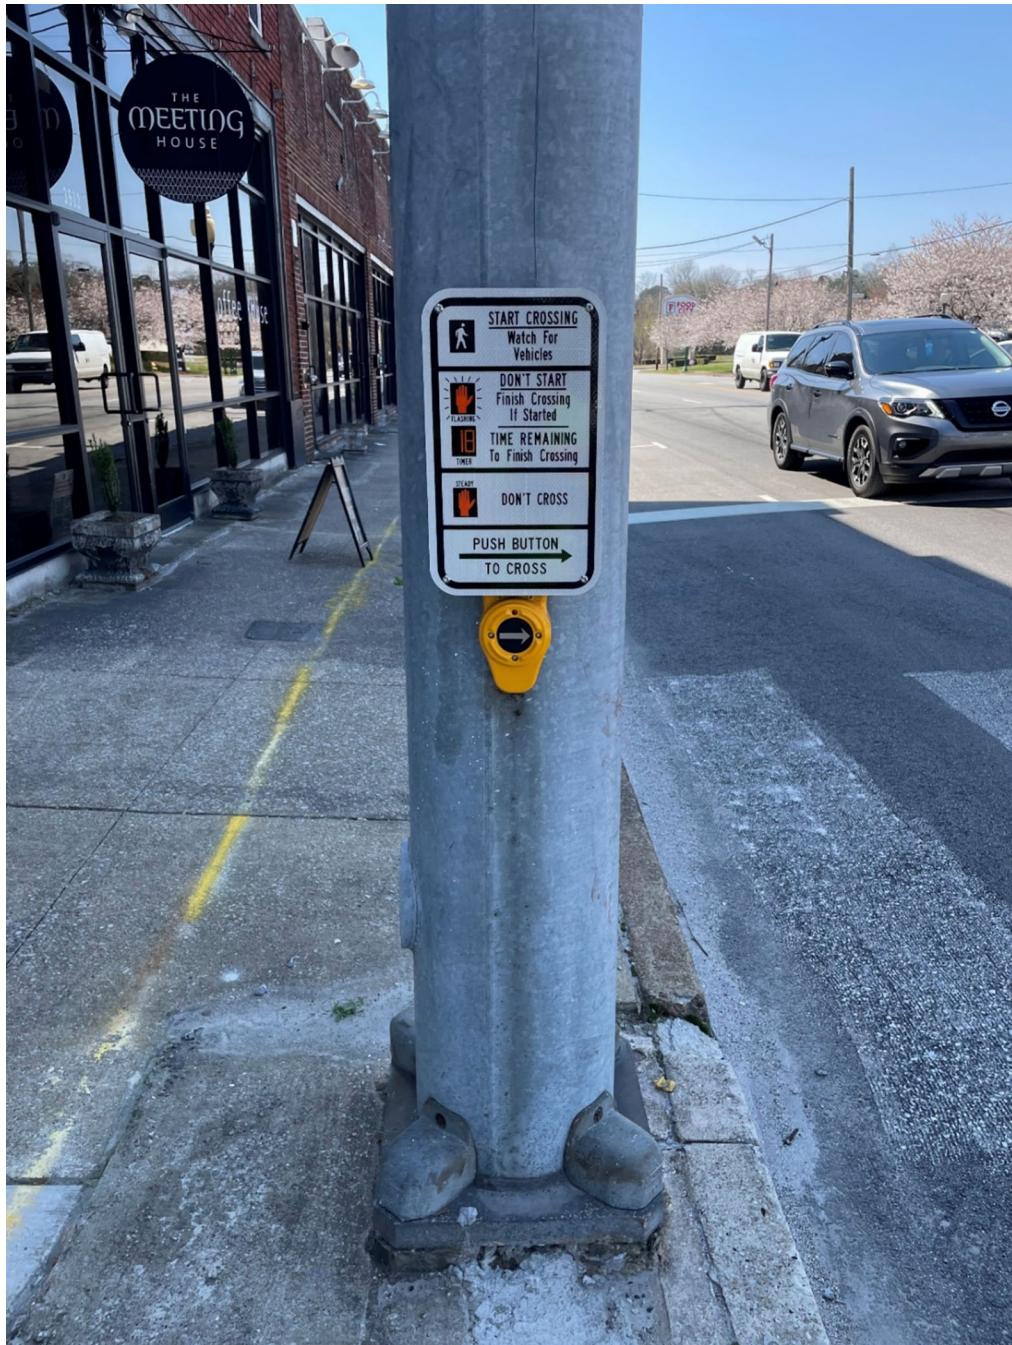
Figure 9 – Southeast Corner Pushbutton for crossing Dayton Boulevard

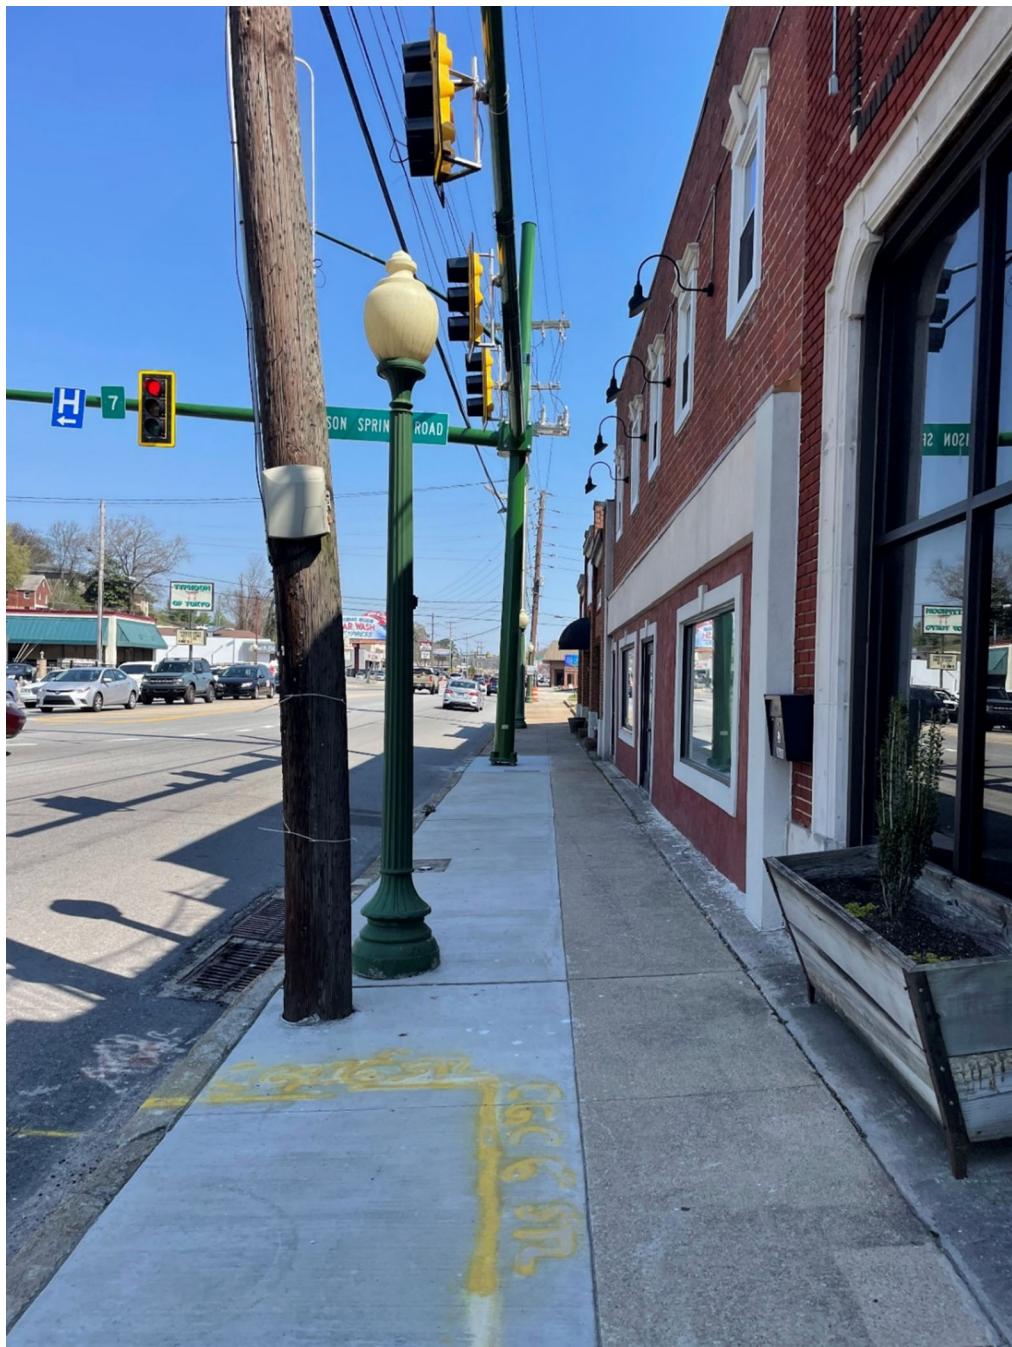
Figure 10 – Northbound Sidewalk along east side of Dayton Boulevard

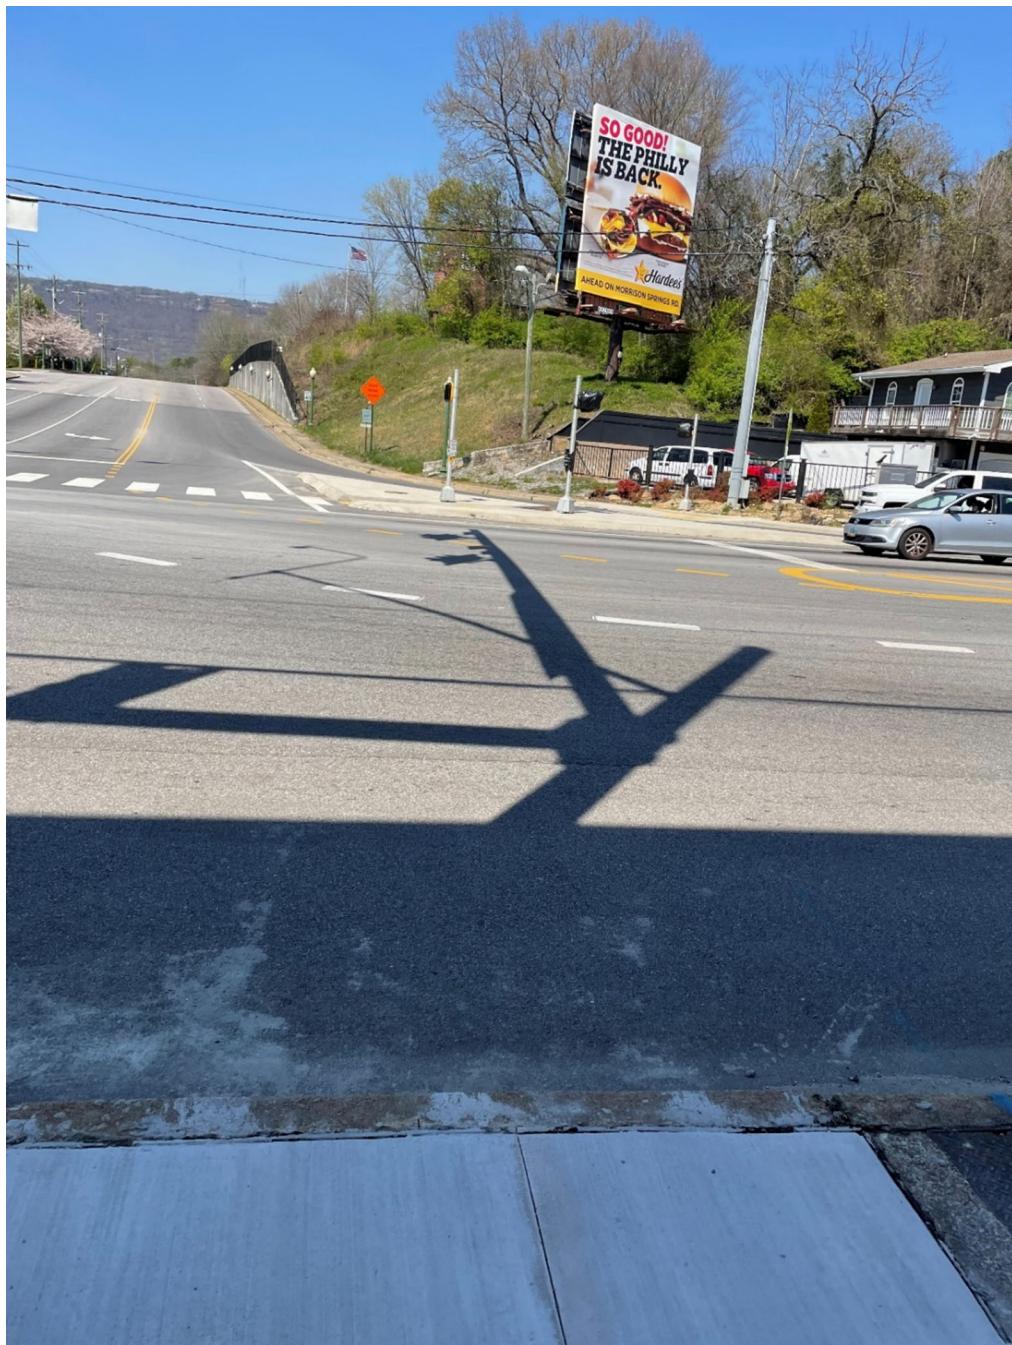
Figure 11 – Looking westbound across Dayton Boulevard (Northeast corner)

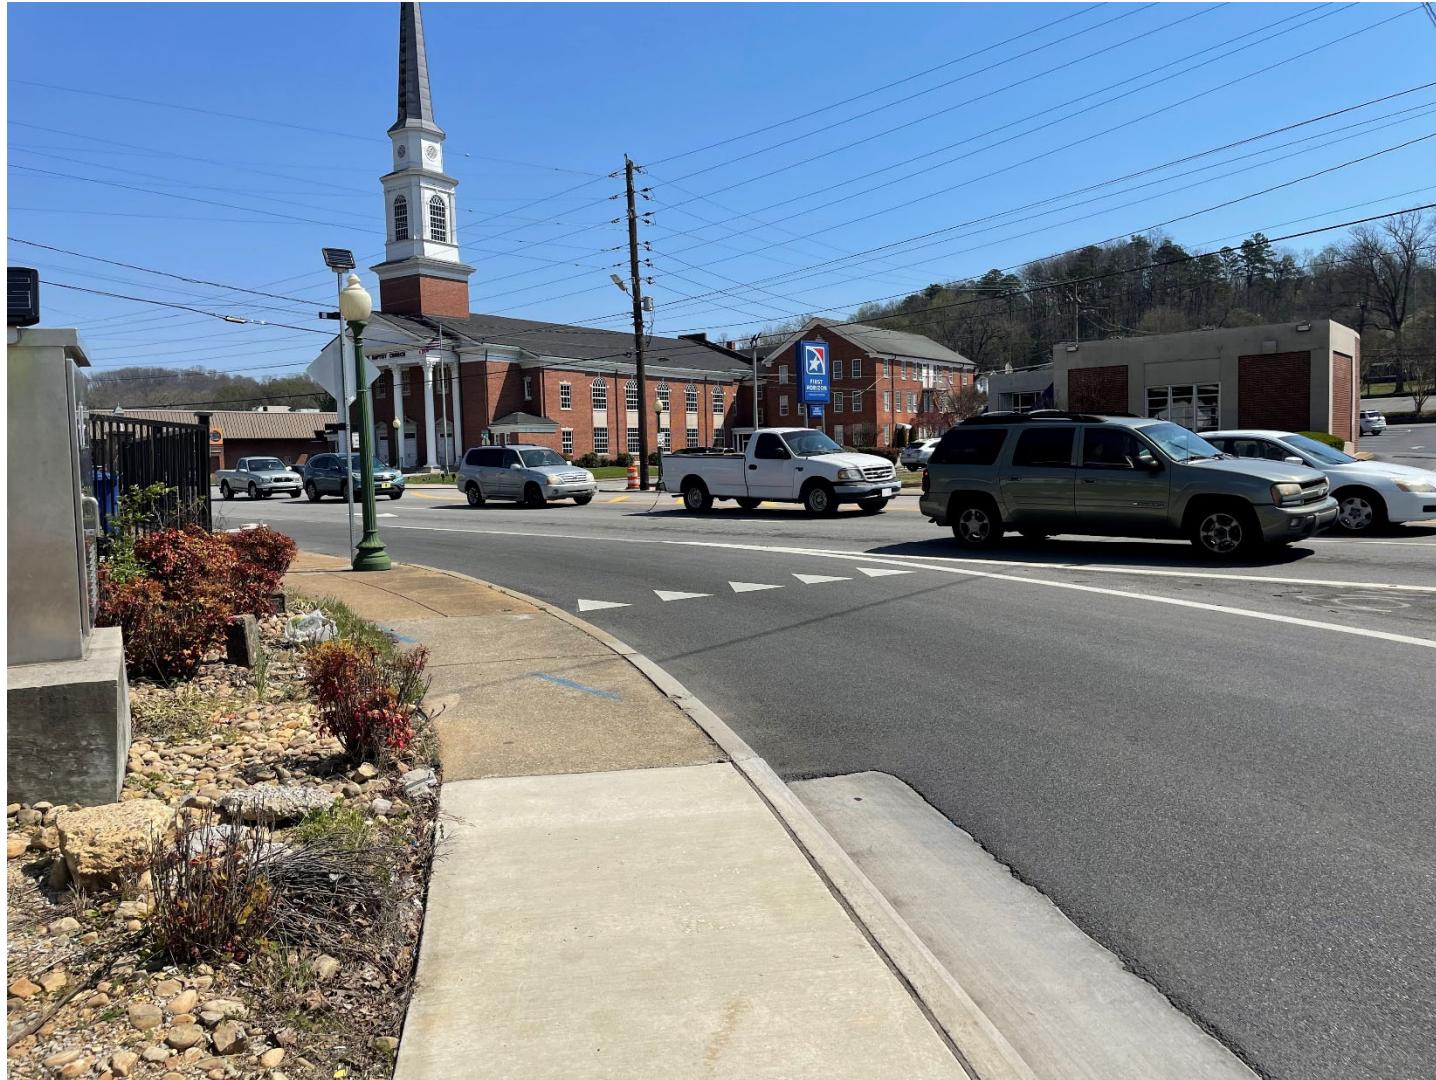
The crosswalk in the northwest corner of the intersection to the concrete channelizing island presents sight distance issues for pedestrians traveling southbound through the channelized crossing. The current location of the pedestrian curb ramp is located in the center of the radius of the right turn lane. Due to the existing business fencing and geometric curvature of the roadway, sight distance is severely limited for crossing pedestrians. Oncoming vehicles cannot see pedestrians wanting to cross the roadway and were observed to be traveling at high rates of speed.

Figure 12 – Looking northbound from existing pedestrian crossing (northwest corner)

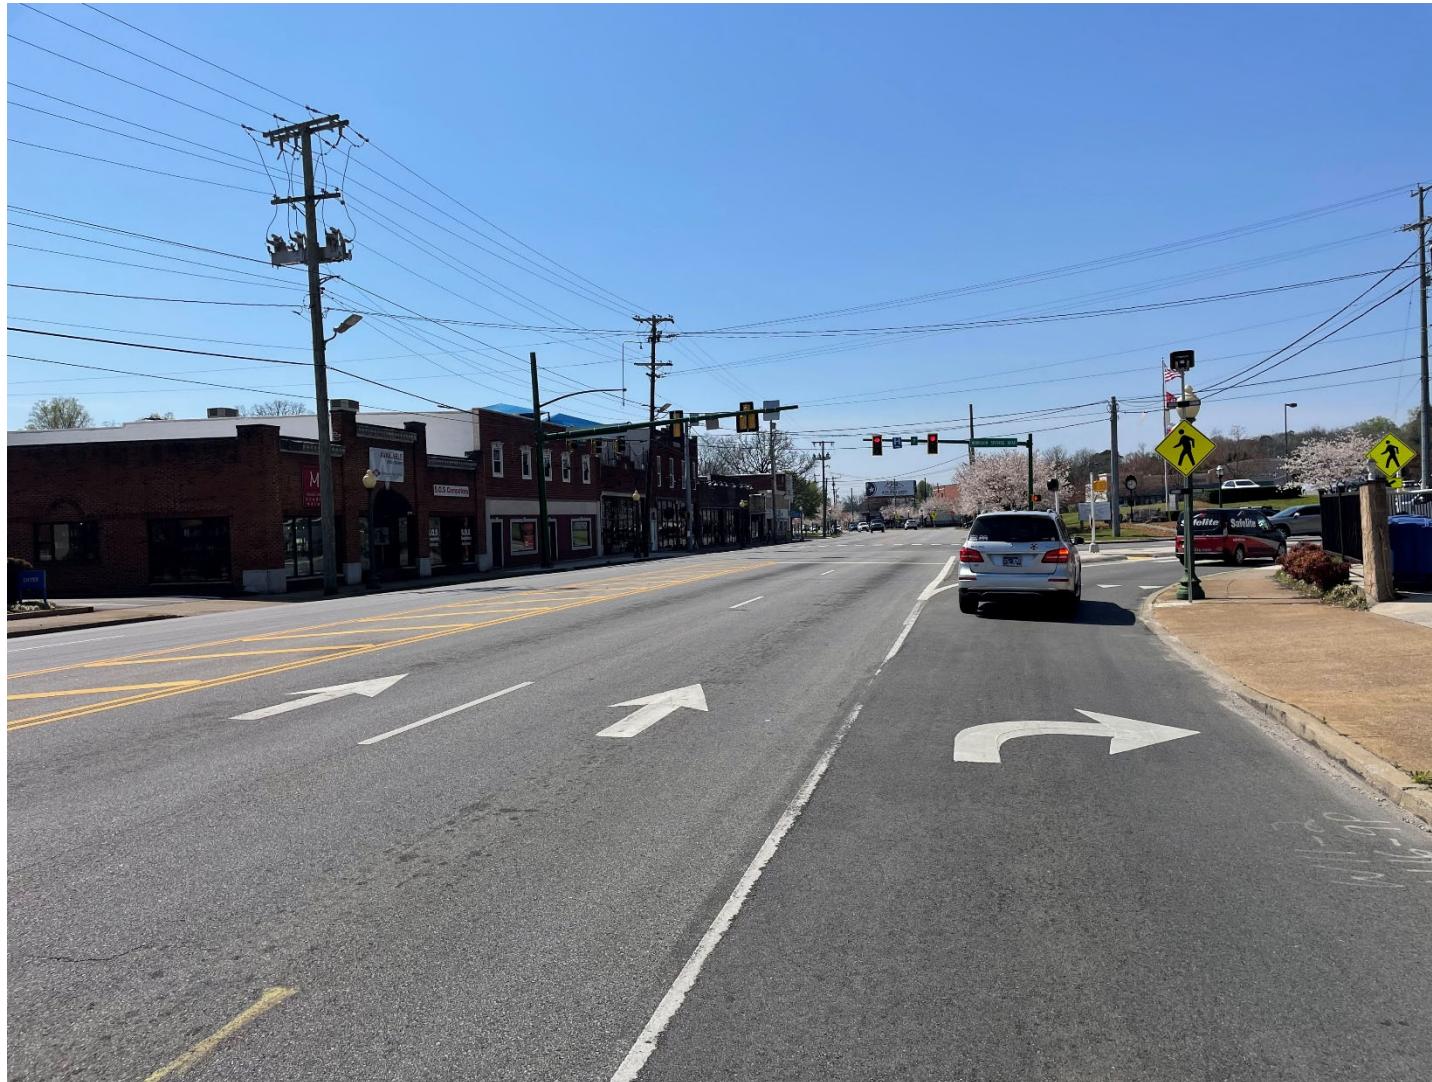
Figure 13 – Southbound Approach of Dayton Boulevard

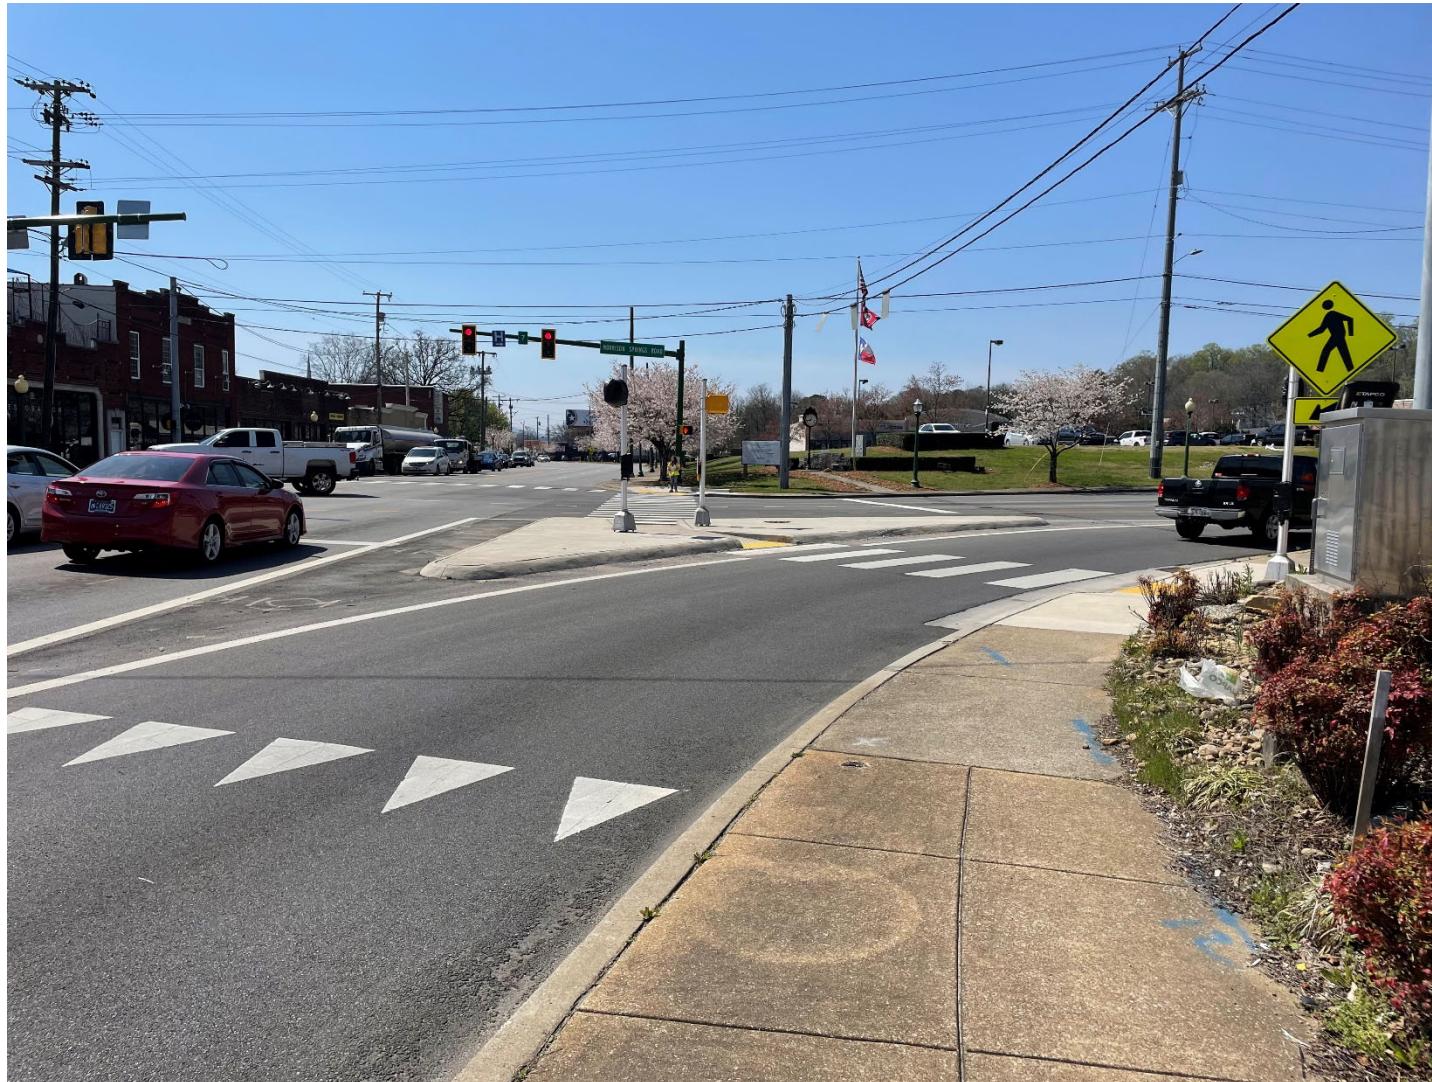
Figure 14 – Southbound Channelized Right Turn Lane of Dayton Boulevard

ST	Restripe approximately 215 feet of retroreflective solid white striping for the southbound channelized right-turn lane along Dayton Boulevard.	Existing pavement marking is worn and faded.
ST	Install approximately 100 feet of retroreflective solid white striping westbound on Morrison Springs Road.	Encourage drivers to stay in their lane while vehicles enter the roadway to improve flow and reduce sideswipe and rear-end collisions.
ST	Install plastic "ONLY" pavement marking 32 feet behind existing right-turn arrows on Morrison Springs Road.	Reduce last-second lane changing by providing drivers with additional warning of lane direction.
ST	Update yellow change interval and red clearance intervals per TDOT Traffic Design Manual.	Provide adequate time for vehicles to clear the intersection before the beginning of the next phase.
ST	Update Max 1 timings with an increase in phase 1 (northbound left) phase length.	Reduce vehicle-vehicle and vehicle-pedestrian conflicts by providing more vehicles to clear during the protected phase.

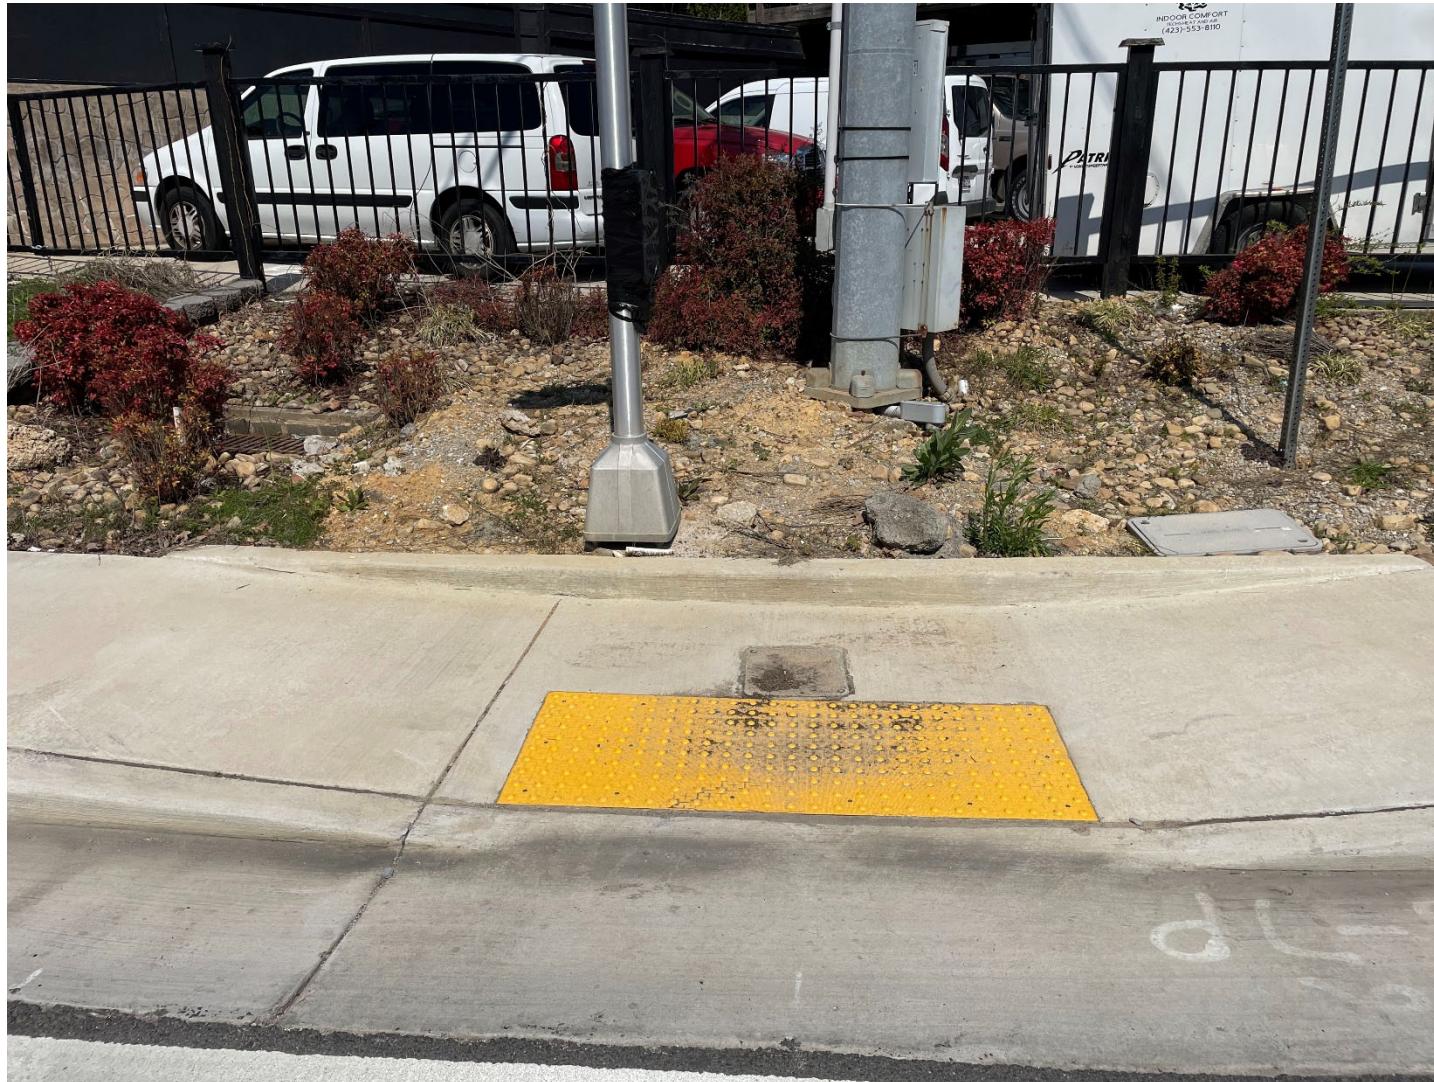
Figure 15 – Northwest Corner Curb Ramp
