# Dayton Boulevard at Morrison Springs Road Safety Analysis Memo

From: Geneva Dowdy, PE CC: Gregory Tate

Project: Dayton Boulevard at Morrison Springs Road

Subject: Intersection Spot Safety Improvements

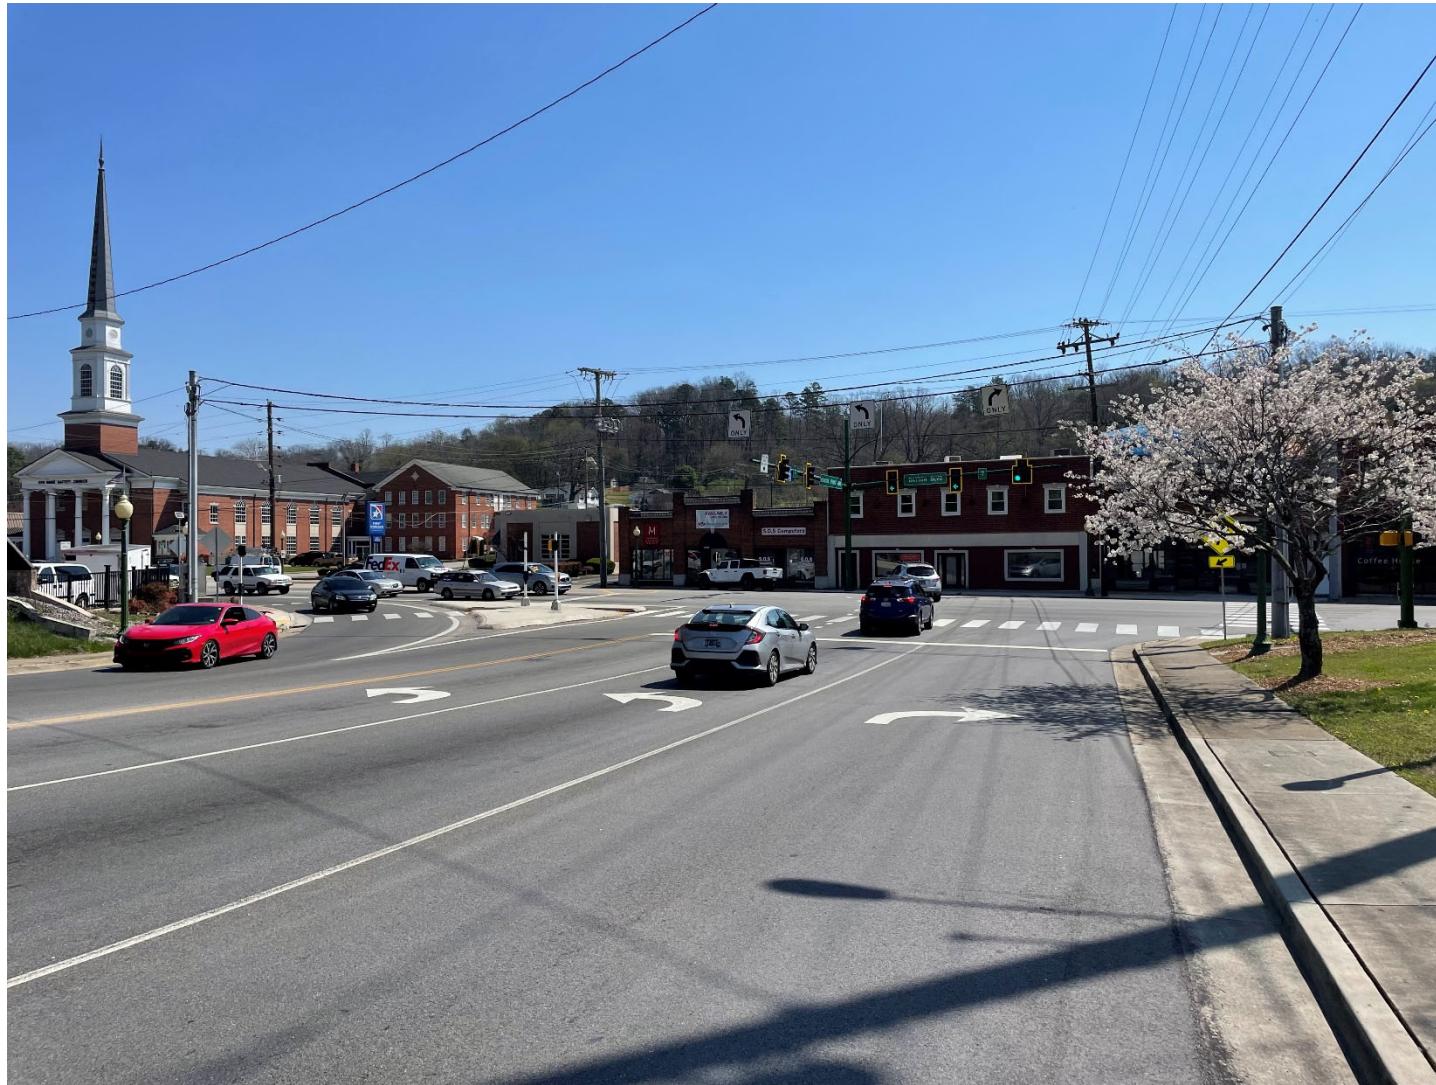
Figure 16 – Eastbound Approach of Morrison Springs Road

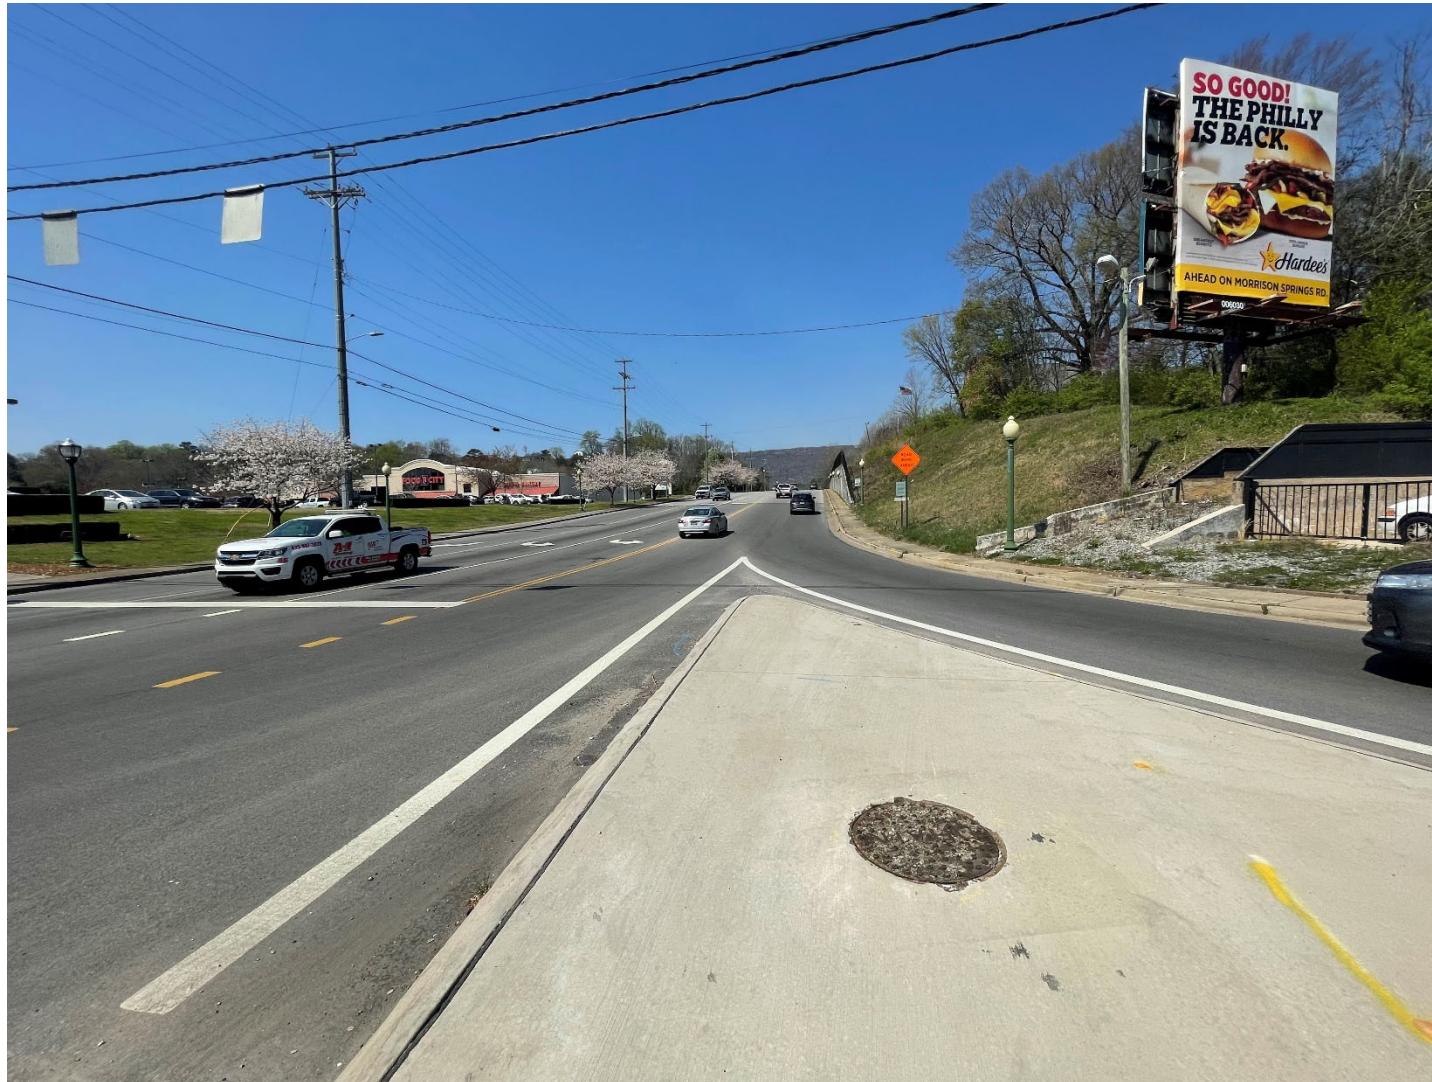
Figure 17 – Westbound receiving lanes of Morrison Springs Road

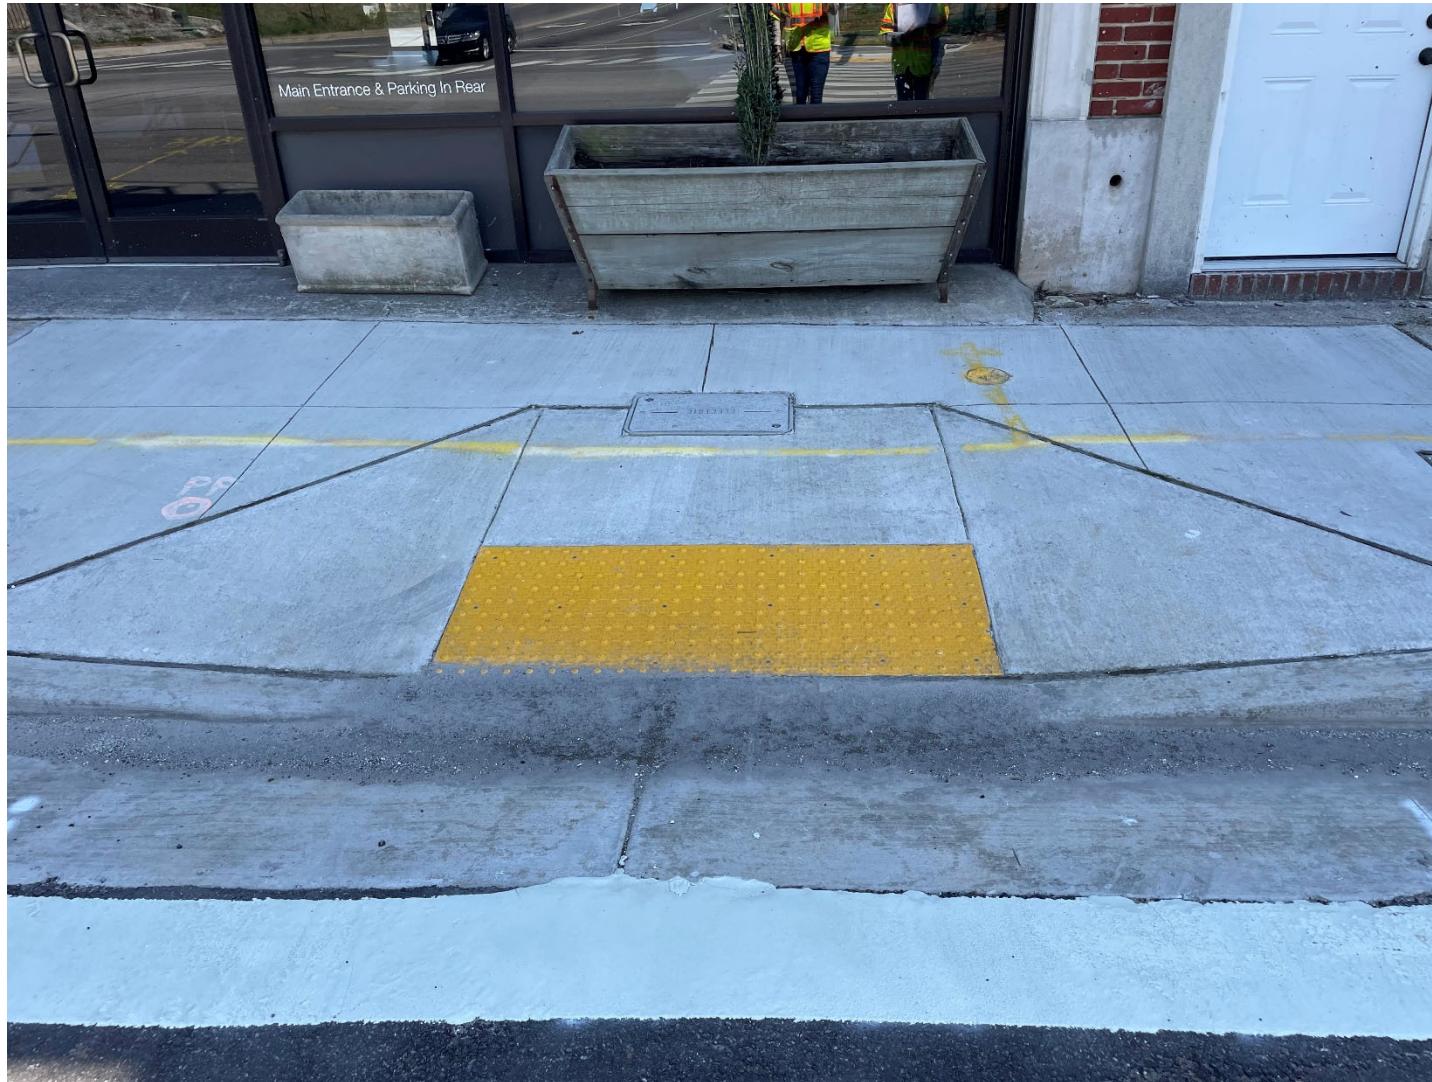
Figure 18 – Southeast Corner Curb Ramp

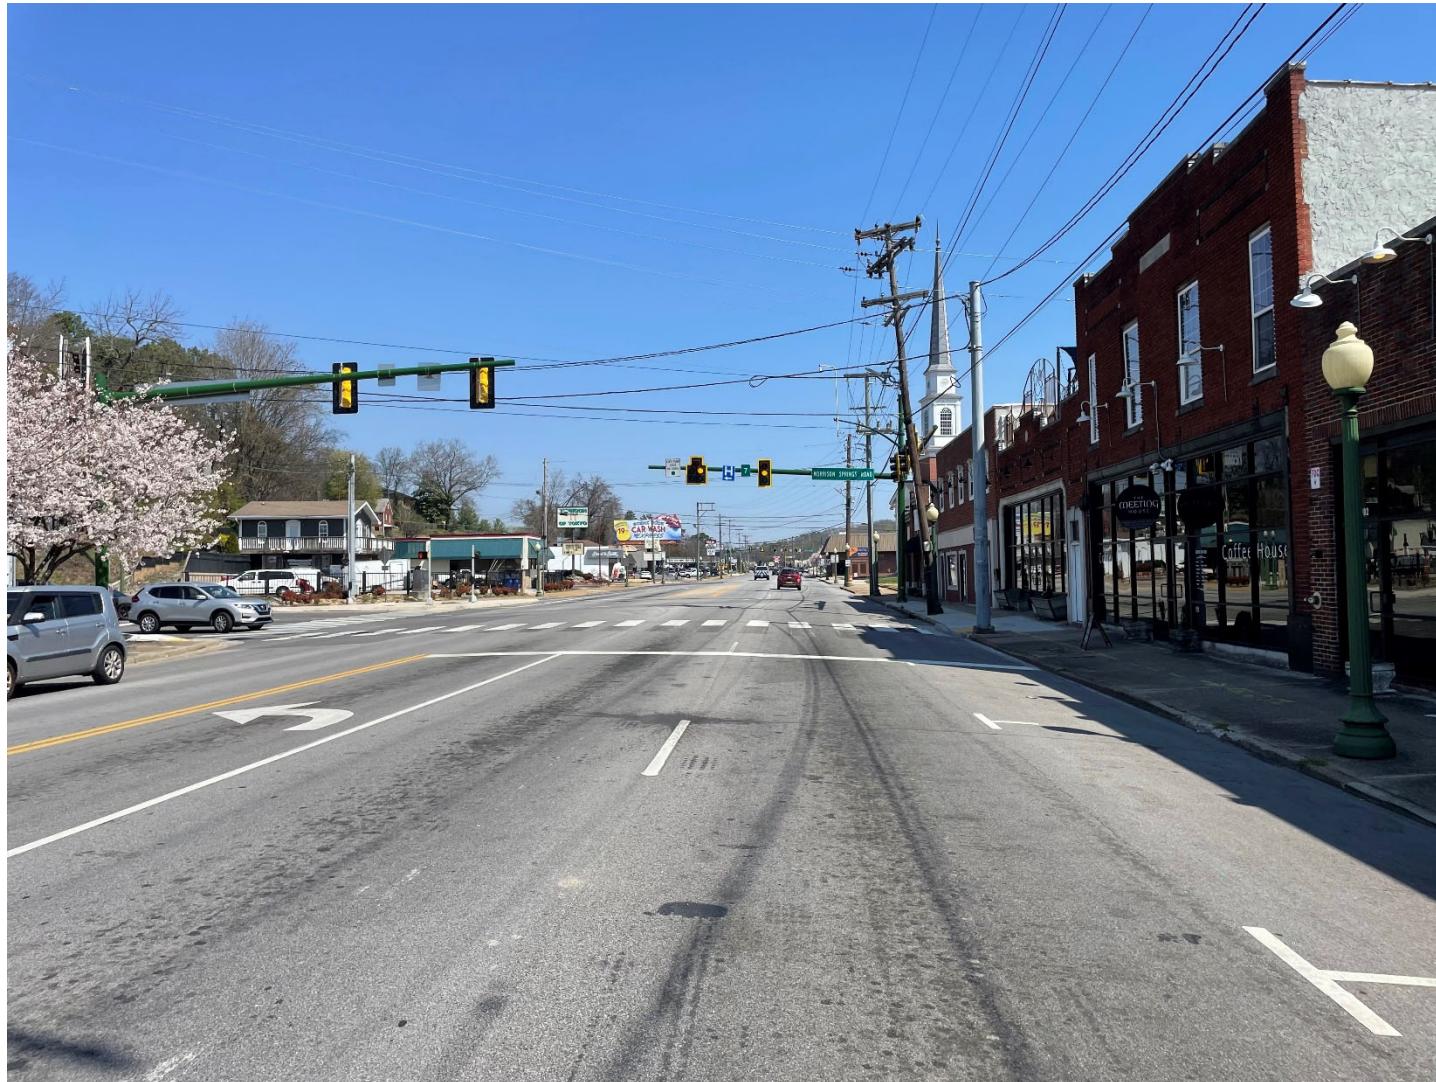
Figure 19 – Northbound Approach of Dayton Boulevard
