# Dayton Boulevard at Morrison Springs Road Safety Analysis Memo

From: Geneva Dowdy, PE CC: Gregory Tate

Project: Dayton Boulevard at Morrison Springs Road

Subject: Intersection Spot Safety Improvements

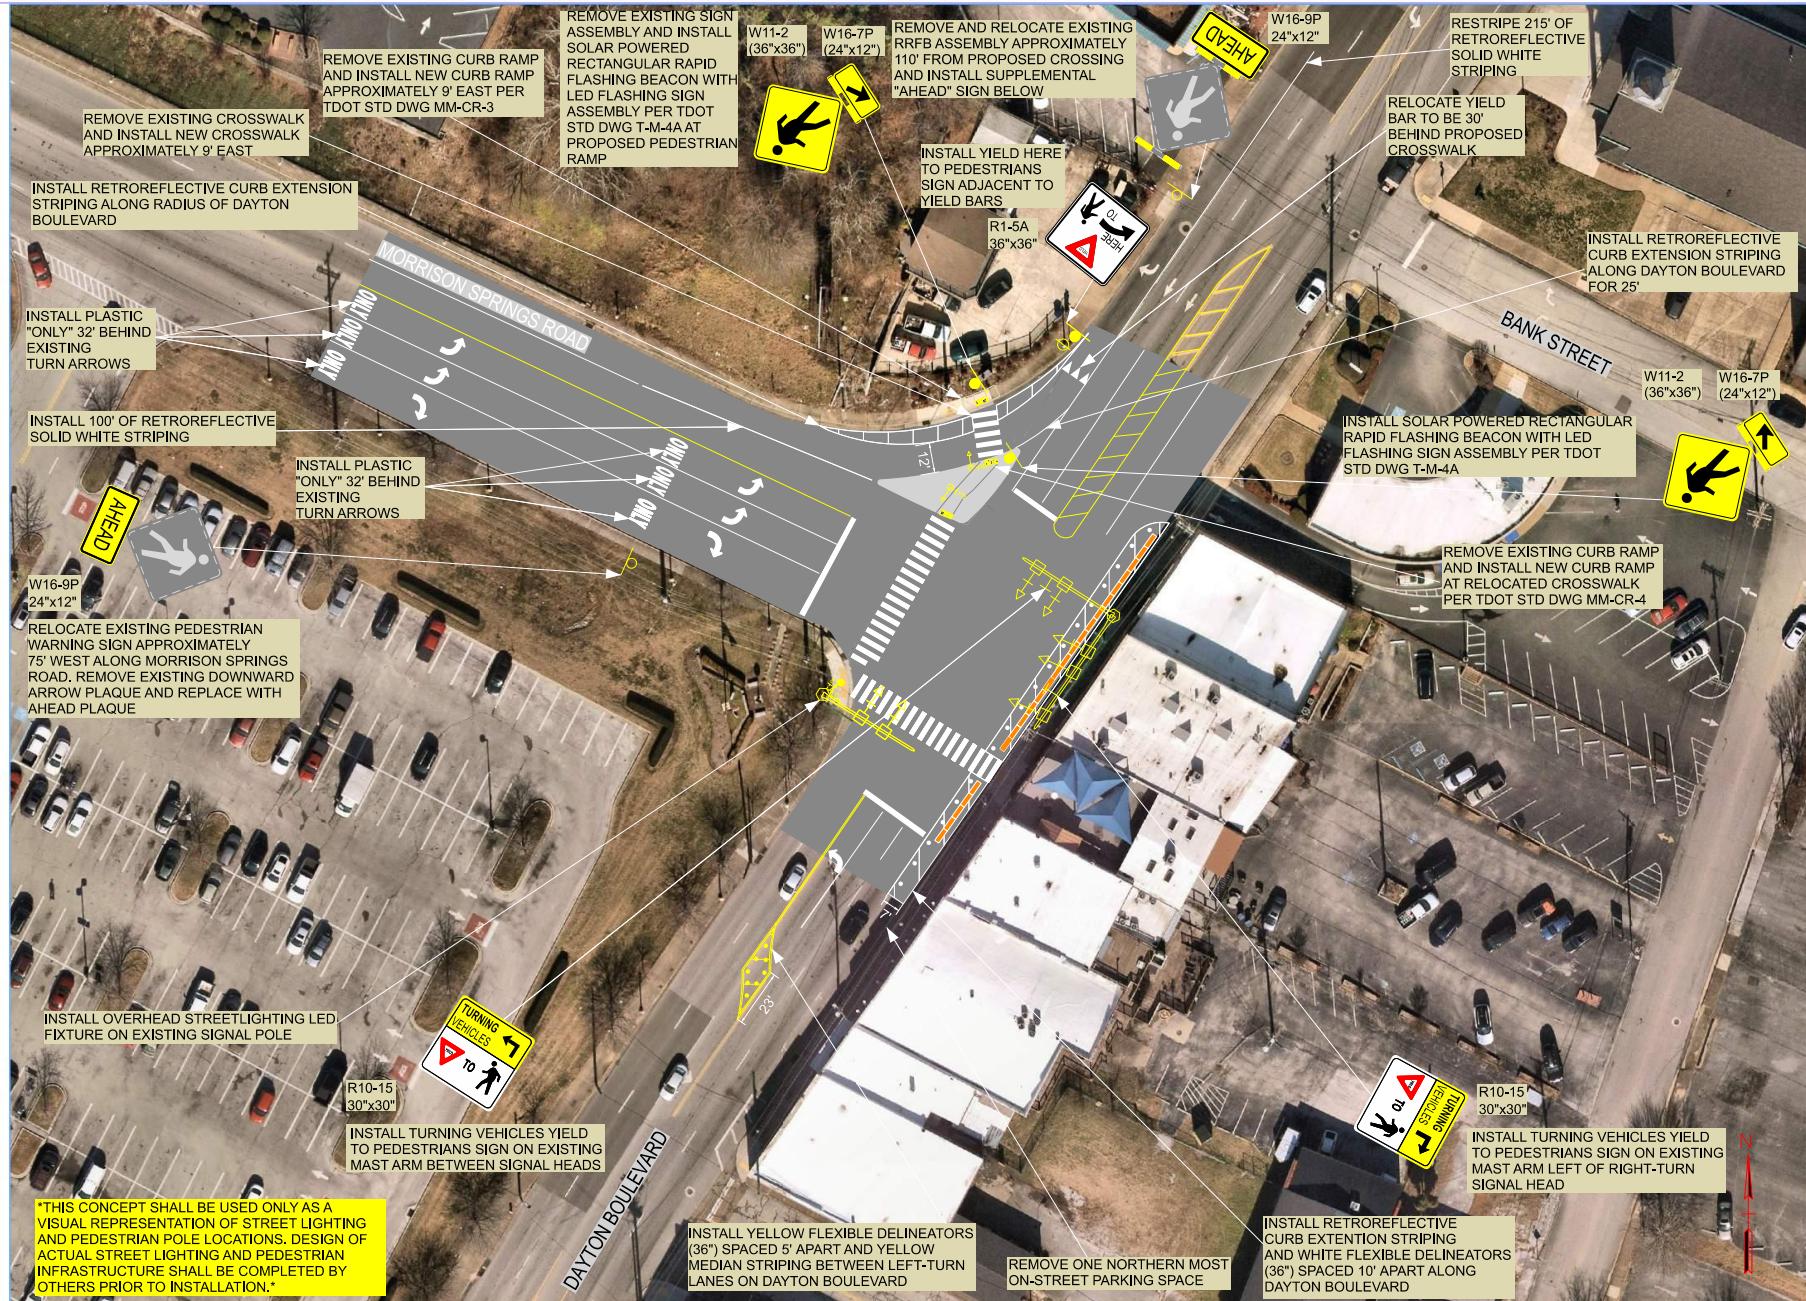
The exhibit below details the recommended improvements as shown in Table 2 above. These improvements are shown as conceptual and any permanent improvements including pedestrian infrastructure should undergo the full design process prior to installation.

PROPOSED STOP BAR  
LOCATION

BARRIERS OFFSET FROM  
CURB APPROX. 1'

Given the nature of this quickly deployable project for the City, water filled jersey barriers are recommended as a temporary crash protection measure along the east sidewalk frontage of Dayton Boulevard. Water filled barriers can be quickly deployed, are more visible to drivers compared to other crash barriers, and are durable enough to last until a longer term engineering solution is addressed along Dayton Boulevard.
